A Durable Airfield Marking System

THOMAS NOVINSON, Ph. D.

JUNE 1985

ENGINEERING & SERVICES LABORATORY AIR FORCE ENGINEERING & SERVICES CENTER TYNDALL AIR FORCE BASE, FLORIDA 32403

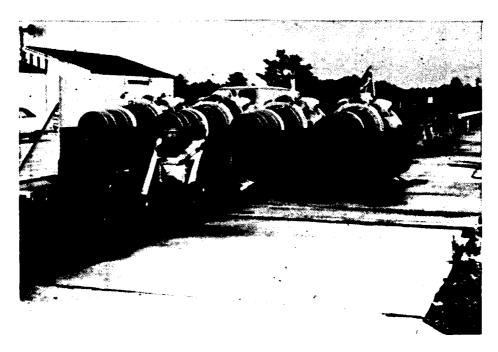
Figure 3. Simulated Jet Aircraft (Sled) Powered by Four Jet Engines. The Sled can Travel at Speeds up to 200 Knots on a 2-Mile Track.

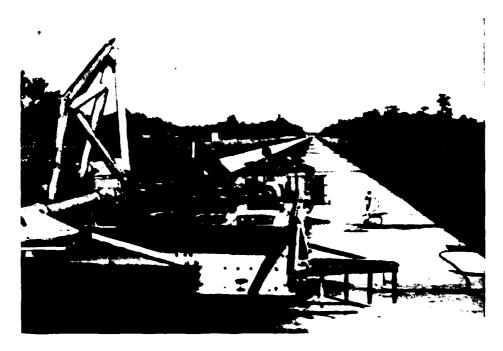
Figure 4. View of the 2-Mile-Long Test Track at NAEC Lakehurst (New Jersey).

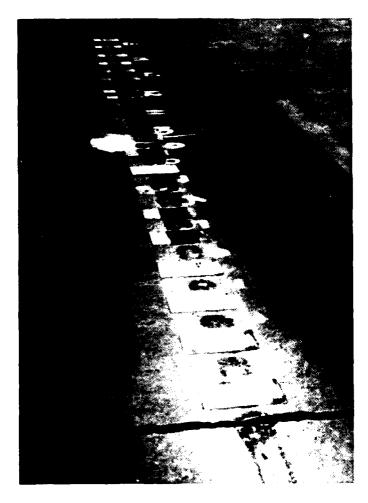
Figure 5. View of the Tapes, CAS Tiles,
Fluorocarbon Tiles, and Paints
with Rubber Skid Marks from the
Simulated Jet Aircraft at NAEC
Lakehurst (New Jersey).

Materials meeting most of the criteria of Section II (ease of installation, cost-effectiveness, and life expectancy were considered in later stages of testing) were then applied in 12- by 6-inch (or similar) lateral stripes on the concrete pavement of the test track at the Naval Air Engineering Center (NAEC), Lakehurst, New Jersey. A simulated jet vehicle was then propelled down the track at 200 knots. The vehicle was stopped with an electronic braking system, causing the same type of rubber skid marks on the pavement and marking materials as an actual jet aircraft. A 10,000-pound load, containing an auxiliary test tire, was dropped onto the track to further simulate actual jet landings. The materials were then examined, and attempts were made to remove the rubber with a scrub brush and detergent solution. Test results are summarized in Table 1. The simulated jet vehicle (sled) is shown in Figure 3, the test track is shown in Figure 4, and the materials being tested on the pavement near the end of the track are shown in Figure 5.

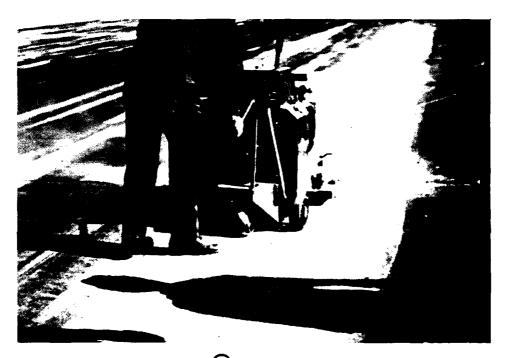
Figure 8. EDCO R Grinder for Small Jobs.

NCEL used a small EDCO grinder to plane the pavements at Elmendorf AFB (Alaska) and NAS Barbers Point (Hawaii) because it was impractical to have a contractor travel to the remote sites for a small grinding job. The EDCO machine is shown in use in Figure 8, and Figure 9 shows a closeup view of the steel cutting blades. Tungsten carbide blades are also available from EDCO.

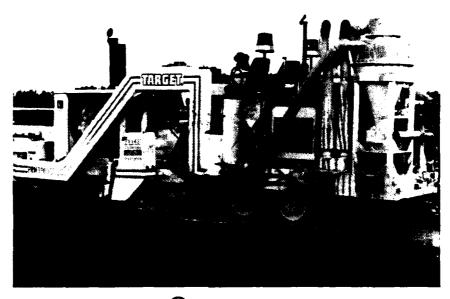
Figure 10. Target RGrinder (Diamond-Tipped Blades)
Recommended for Large Jobs.

The larger Target grinder, which was used by the contractor at Homestead AFB (Florida), is recommended for all large jobs. This grinder (Figure 10) has diamond-coated steel cutters on a 3-foot-wide cutting drum (Figure 11), which is efficient enough to cut a 1/4-inch-deep trough (3 feet wide) in one pass.

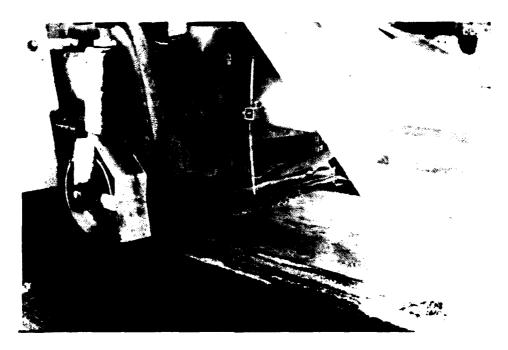
Figure 11. Closeup View of the 3-Foot-Wide Diamond Cutting Blades.

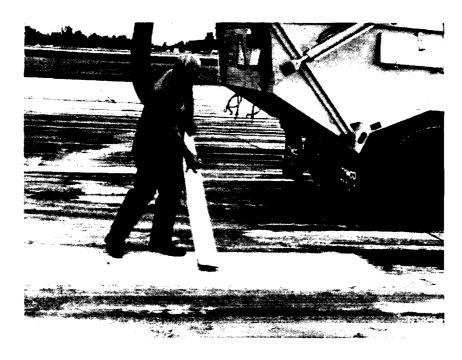
Figure 12. After the Concrete is Ground Down or Planed, the Debris and Water (to Cool the Diamond Cutters) must be Vacuumed off.

Since the cutting blades are cooled by water spraying, the water must be suctioned with a vacuum unit, as shown in Figure 12.

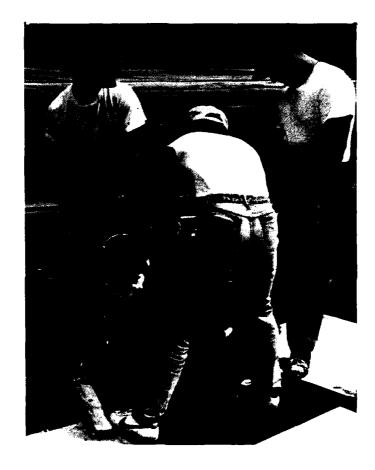
Figure 13. The White Epoxide Resin is Mixed with the Black Curing Agent to Form the Epoxy Adhesive.

The two-component epoxy adhesive is then mixed (Figure 13) and applied to the back surface (metal) of the plates (Figure 14) and the pavement (Figure 15). It is best to coat only two or three plates and 6 to 9 $\rm ft^2$ of pavement so that the plates can be laid in place (Figure 16) while the adhesive is still tacky.

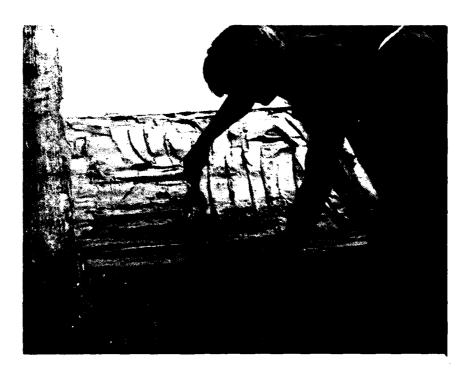
Figure 15. The Pavement is also Coated with Adhesive.

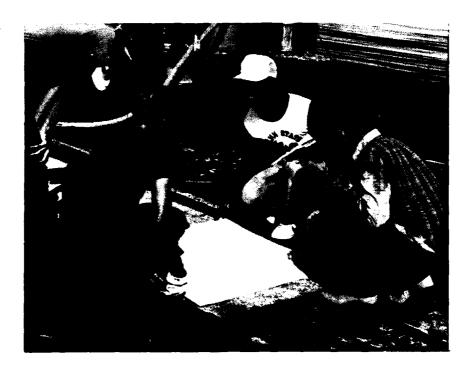
Figure 16. The CAS Tile is Laid in Place.

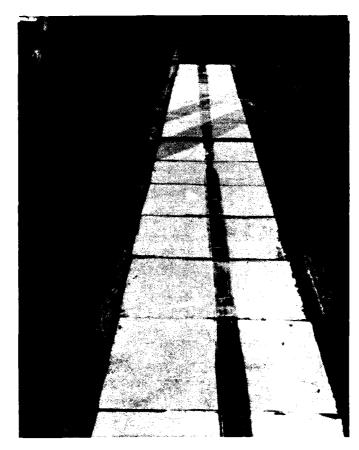
Figure 19. Jet Aircraft Leave Rubber Tire Skid Marks on the CAS Tiles.

When the installation is complete, rubber from the tires of landing jet aircraft will adhere to the CAS tiles (Figure 19), but these rubber deposits are easily removed (Figure 20). The rubber is best removed by spraying the CAS tiles with an aqueous detergent and then wiping off the deposits with cloths or a mechanical buffer.
